PROBLEMS OF LANDSCAPE ARCHITECTURE
IN
THE NATIONAL FORESTS

REPORT TO U. S. FORESTER'S OFFICE
ON
TRIP OF INSPECTION THROUGH SOME OF THE NATIONAL FOREST AREAS
IN
REGIONS 2, 4, 6 AND 1

BY
A. D. TAYLOR
CONSULTING LANDSCAPE ARCHITECT
SEPTEMBER 1935

(July 26, 1935 through August 22, 1935)

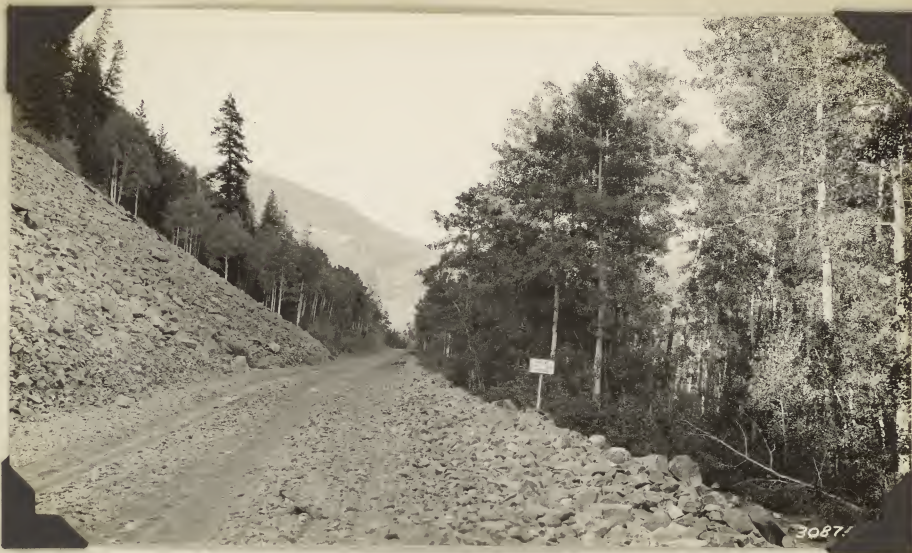
White River National Forest - Entrance on New Castle-Buford Road

This shows the point of entrance to this National Forest along the New Castle-Buford Road. It is a difficult location in which to construct an appropriate feature for the forest entrance.

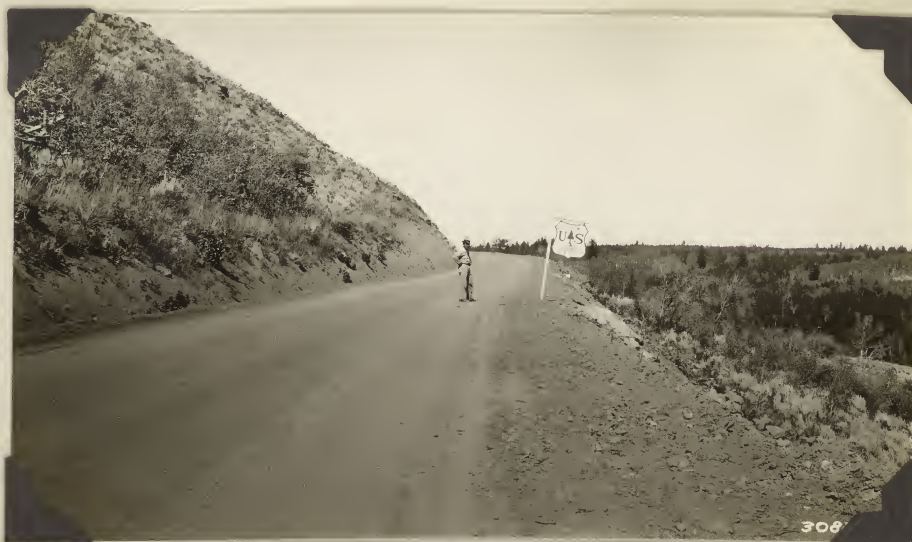
Targhee National Forest - Yellowstone Highway Entrance (Route 191)

Photograph No. 308805 (page 151) shows the existing conditions at the point which marks the entrance to the Targhee National Forest on Route No. 191. Some very careful study will be required in order to develop an appropriate entrance feature for this location, especially because of the steep slope on the lower side of the road.

View of the location for proposed entrance feature. This location presents a very difficult problem in designing an appropriate feature on account of the steep slope on the right side of the road. Existing feature is inadequate.

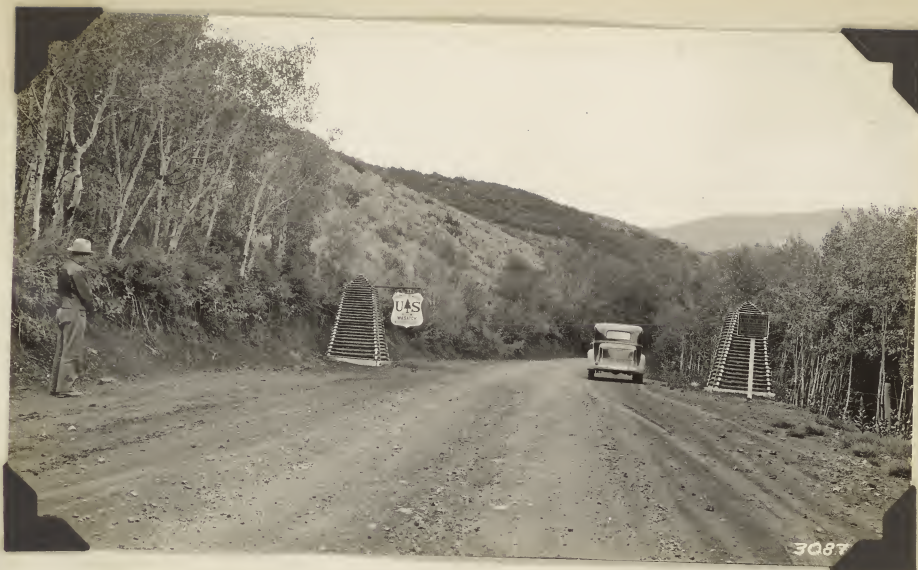
Wasatch National Forest - Provo River-Hayden's Ford Road

General view of feature marking the entrance to Wasatch National Forest. This type of construction is not permanent and does not seem to be appropriate for a forest entrance. Note the highway sign which is placed in an unfortunate location in relation to the pier.

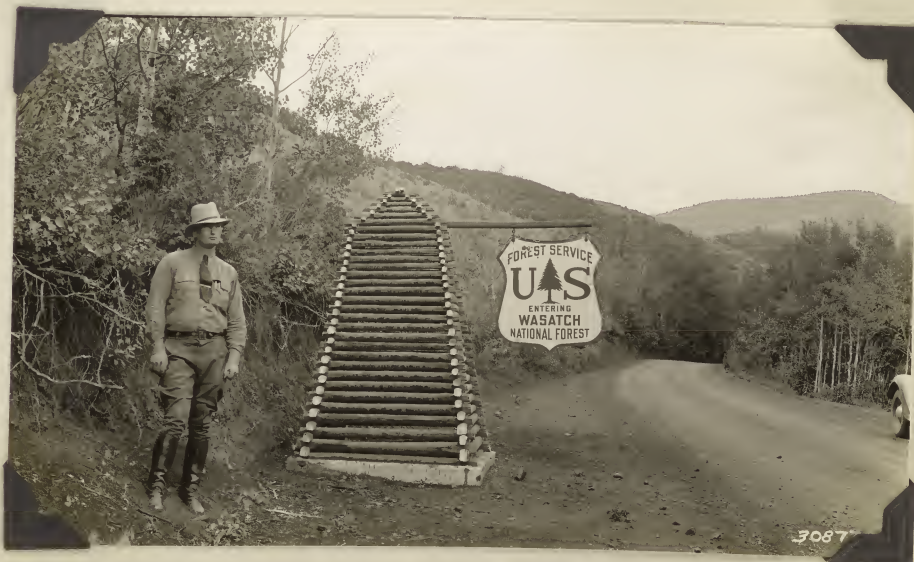
Wasatch National Forest - Provo River-Hayden's Ford Road

Detail view of the pier which marks the entrance to the Wasatch National Forest. Note the comments under photograph No. 308772.

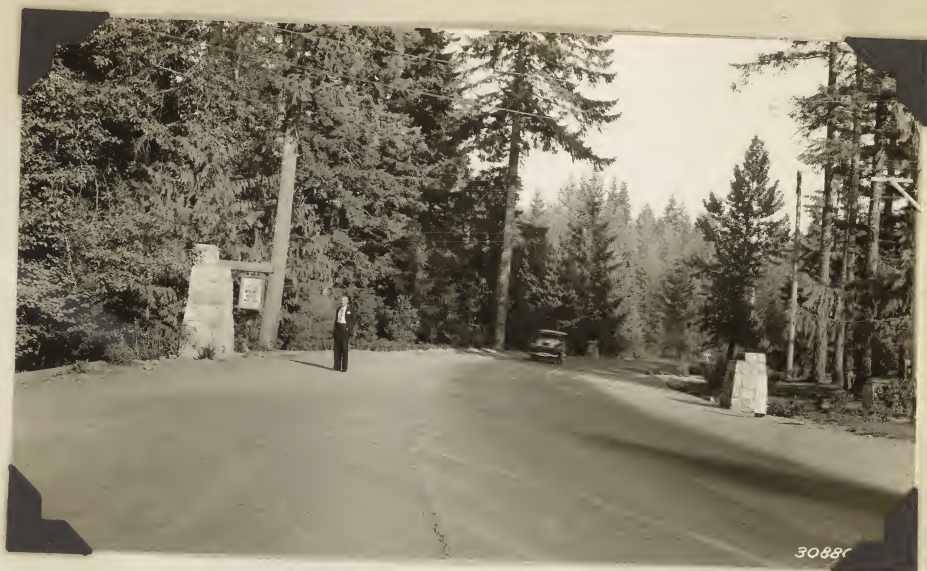
Mount Hood National Forest - Main Entrance Feature

General view of the main entrance. The piers, although of excellent design, seems too small and out of scale with this location. The piers also seem to "float" because of the unusual width between them. "Zigzag Ranger Station" is immediately back of the right pier.

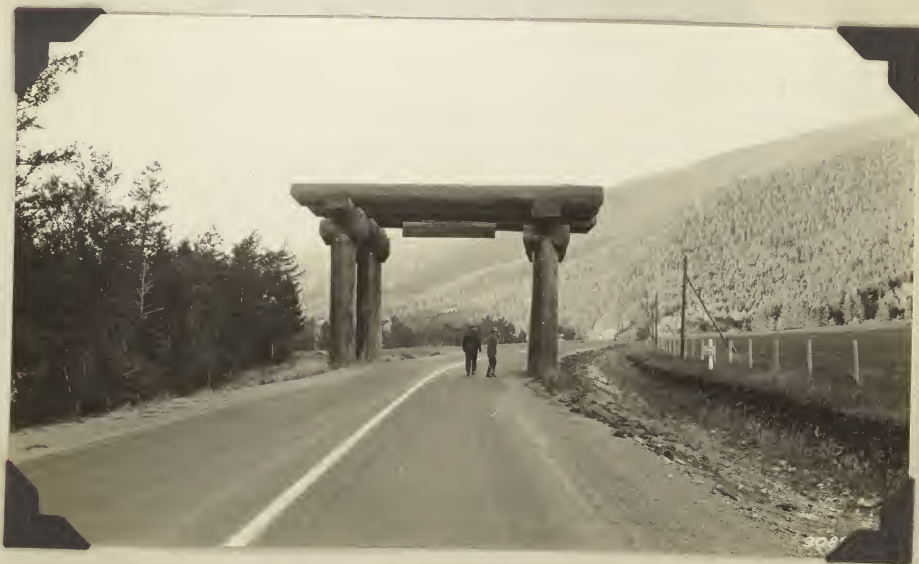
Gallatin National Forest - Entrance to Forest

General view showing the important and impressive entrance feature constructed to mark the entrance to this forest. This feature could be much more effective if the proper grading and planting were completed in the immediate area on either side of the road.

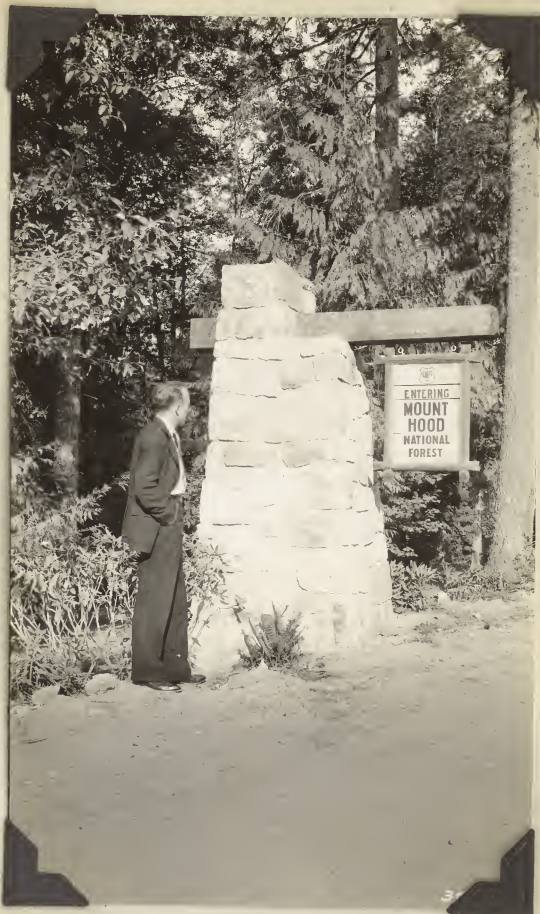
Mount Hood National Forest
Main Entrance to Forest Area

Detail photograph of one of the large stone piers which defines the entrance to the Mount Hood Forest. Piers of this type should have a forest ground cover around the base in order to create a more naturalistic condition, and in general the piers should be larger in scale and the sign should be raised.

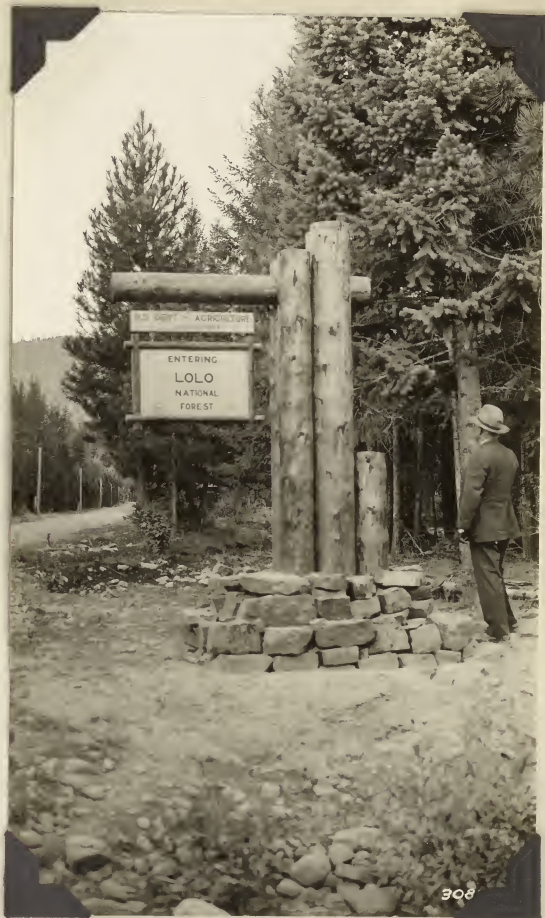
Lolo National Forest

Detail view of the sign marking the entrance to this forest area. The customary procedure of placing a pile of stones around these signs detracts very much from the character of the sign.

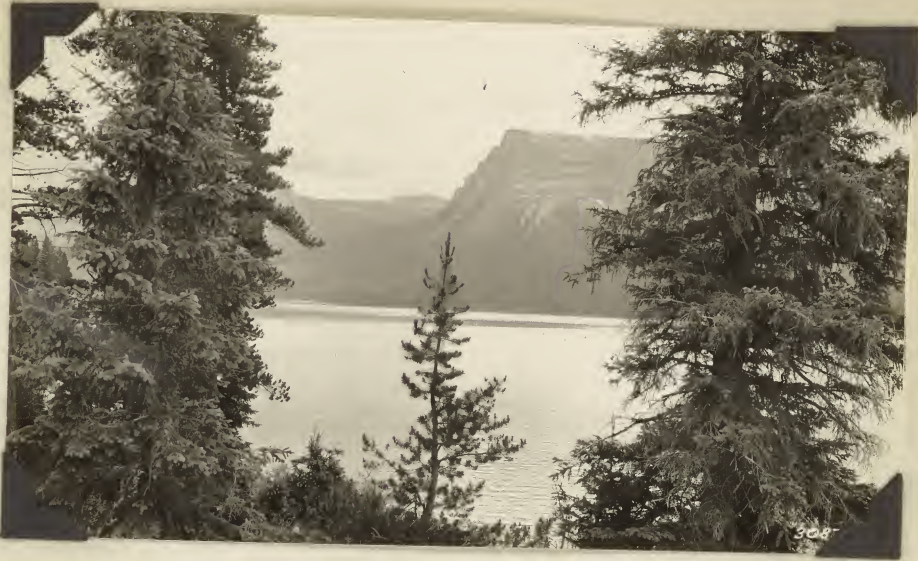
White River National Forest - Trapper's Lake

A very fine view from the shores of the lake, looking across the lake to one end of Amphitheater Mountain, with the distant ranges of the primitive area in the extreme background. Where possibilities for these wonderful views occur, the sacrifice of an individual tree, such as the one in the middle of this composition, should be readily accepted in order to enhance the view.

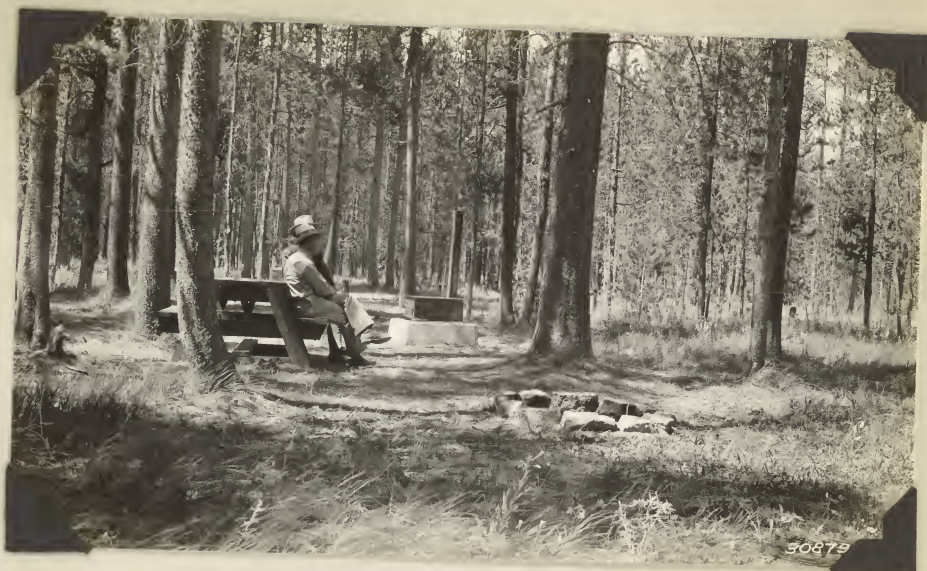
Targhee National Forest - Buffalo Forest Camp

General view showing camp sites in this area. Note the excellent cover of vegetation which is not being destroyed by over-use. Also note the stove, picnic table and fire-pits comprising this unit.

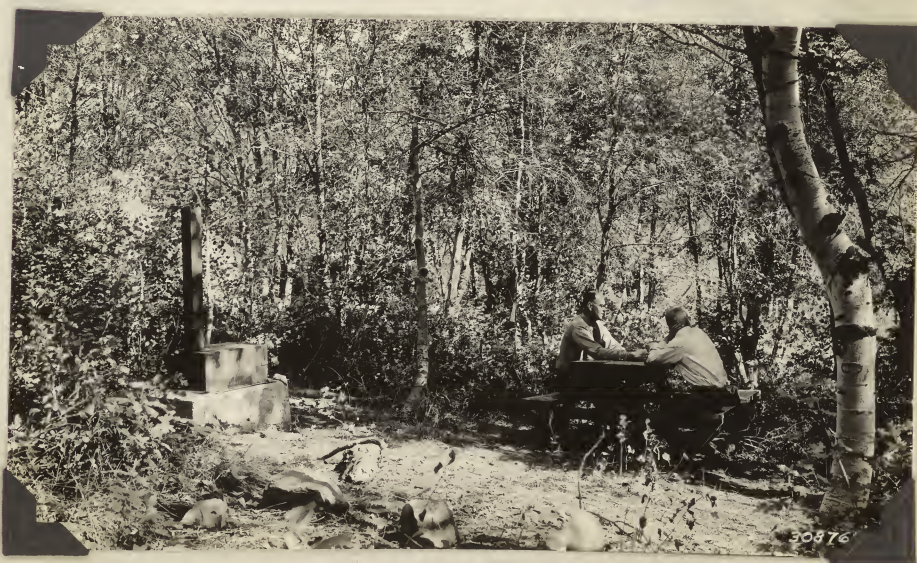
Wasatch National Forest - Aspen Grove Picnic Area

General view of picnic unit showing the natural vegetation not yet destroyed. This type of picnic stove may be extremely practical in actual use. It is not an appropriate feature as now constructed for a forest camp or picnic area, and some study should be given to the possibility of adopting a more rustic feature for this unit.

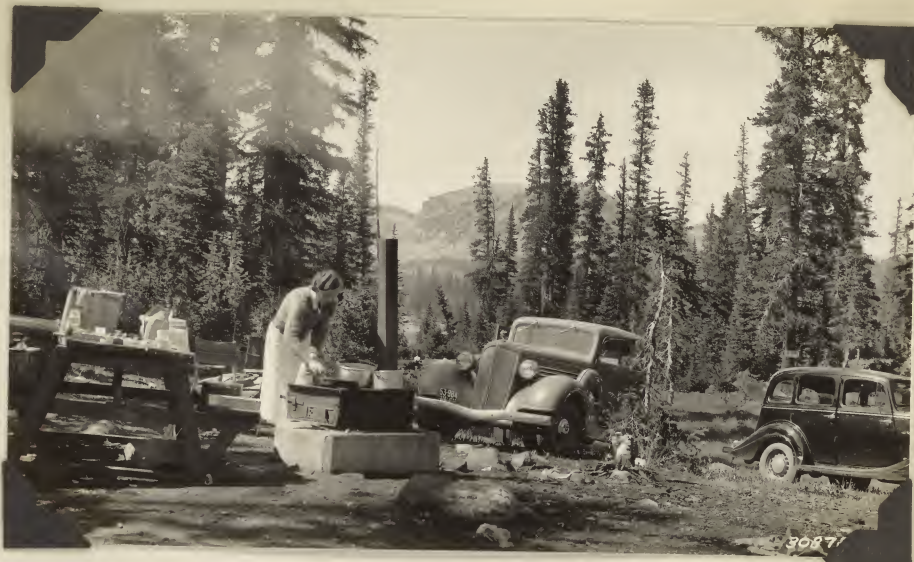
Uinta National Forest - Mirror Lake

Typical camp unit showing the preparation of the noonday meal. Note the unrestricted opportunity for automobiles to drive to the camp sites, unnecessarily destroying existing vegetation and detracting very much from the forest atmosphere such as the camp is really seeking.

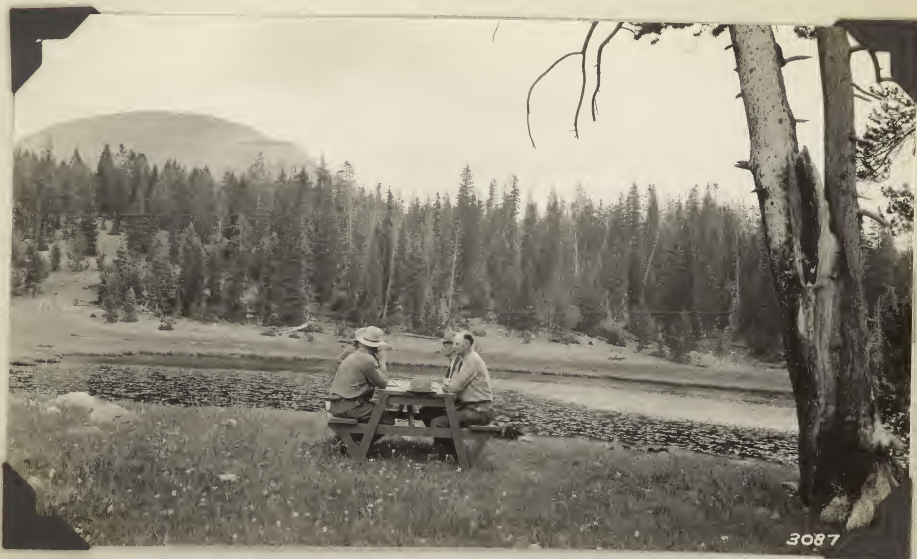
Uinta National Forest - Lily Lake

General view showing the picnic tables located near Lily Lake, with Bald Mountain in the extreme background. Occasionally there is justification for placing a picnic table in such a location where people may enjoy the atmosphere of the open areas and the interesting view of the meadows and of the water studded with lilies.

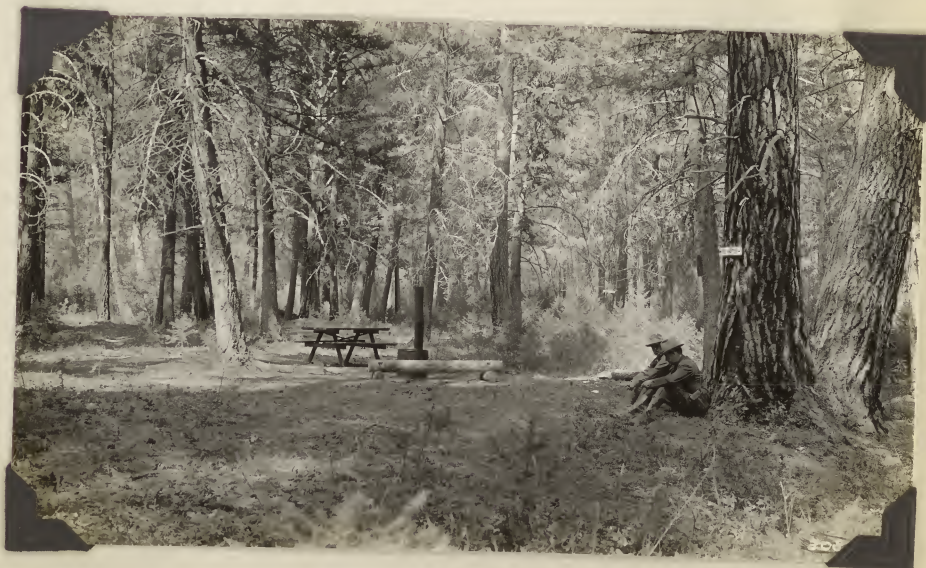
Targhee National Forest - Buffalo Forest Camp

Detail view of a camp unit being occupied by typical campers who procure their major recreation from fishing.

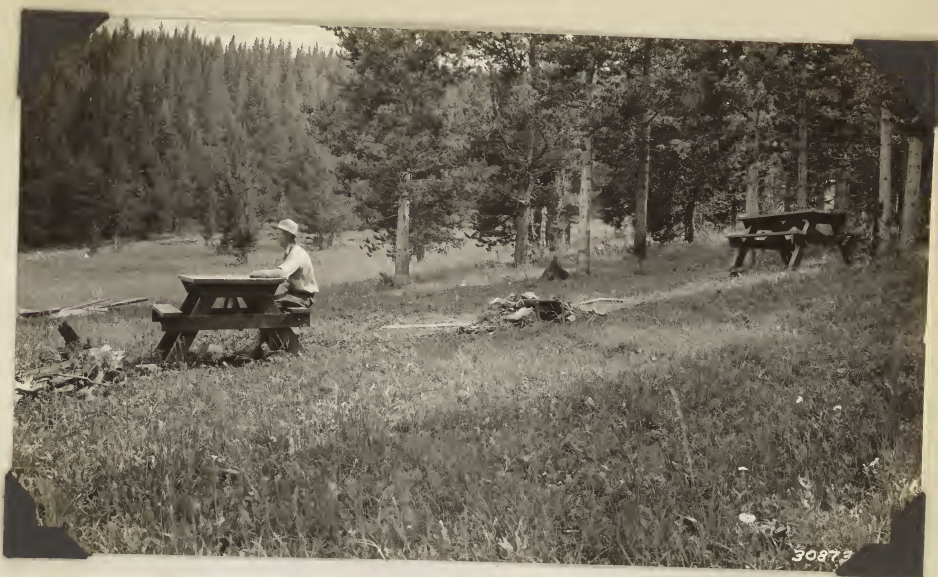
Lolo National Forest - Rock Creek Forest Camp

General view of this camp ground area showing the extremely attractive character of the very natural vegetation cover not yet destroyed.

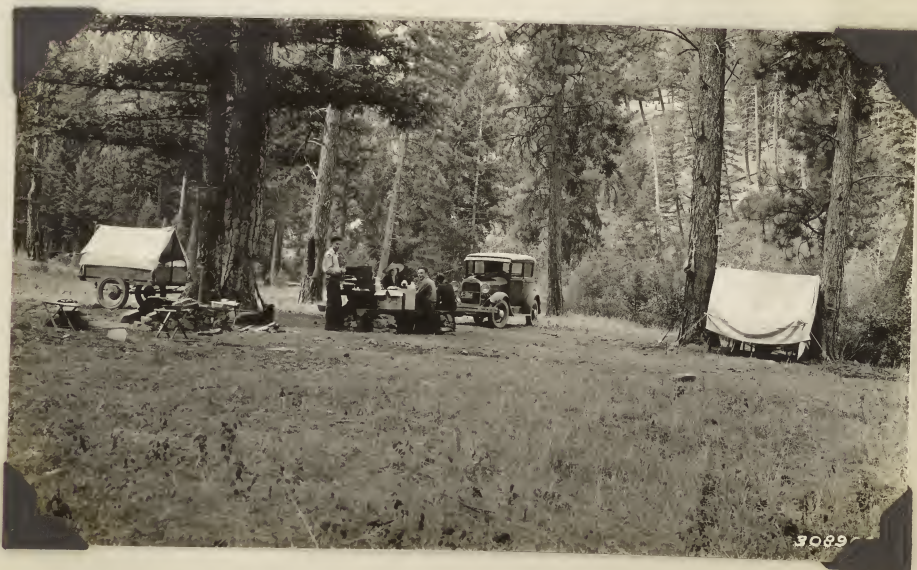
Holy Cross National Forest - Tigiwon Forest Camp

General view showing area adjacent to a picnic table and fireplace, where the natural cover of vegetation has not yet been damaged by intensive use.

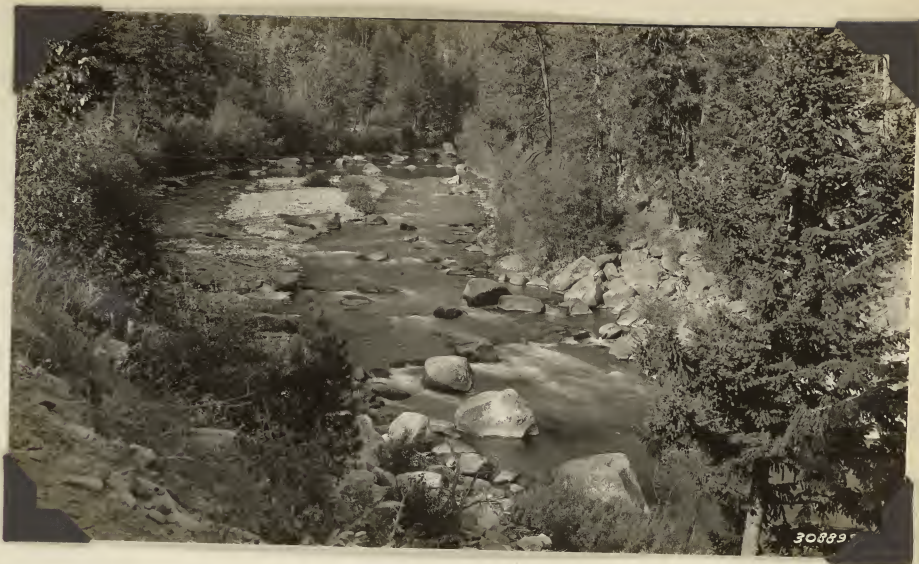
Lolo National Forest - Bitterroot Flats Forest Camp

General view of typical camp unit seen in this camp ground. In such camp areas there must be a feeling of freedom, created by locating camp units at some distance from each other.

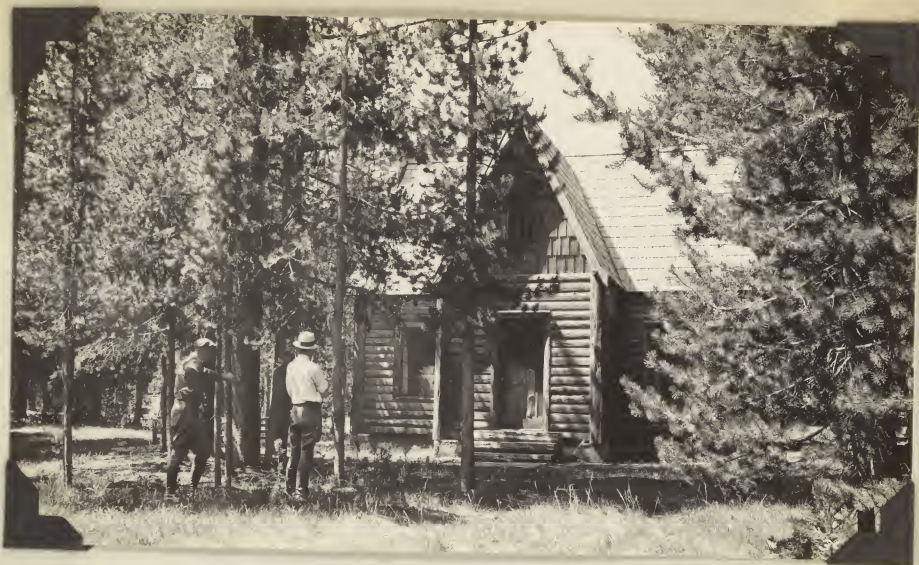
Deschutes National Forest - Diamond Lake

Detail view of a most attractively designed summer camp in the Special Use area.

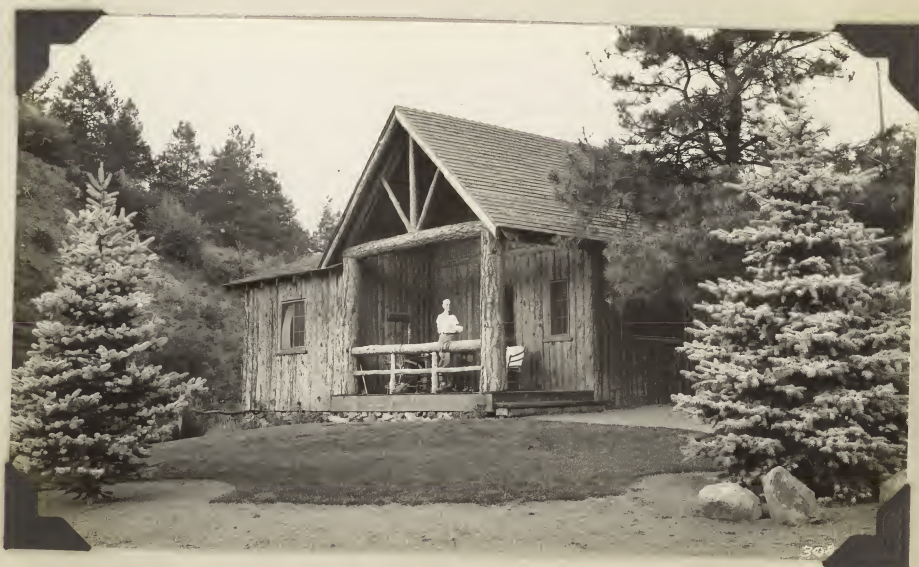
Pike National Forest - Wigwam Club

An excellently designed mountain cabin located in a very natural setting. Such cabins are a real asset to the forest area and can be built at no greater expense than is involved in the construction of cabins in which little real consideration has been given to the exterior proportions and texture.

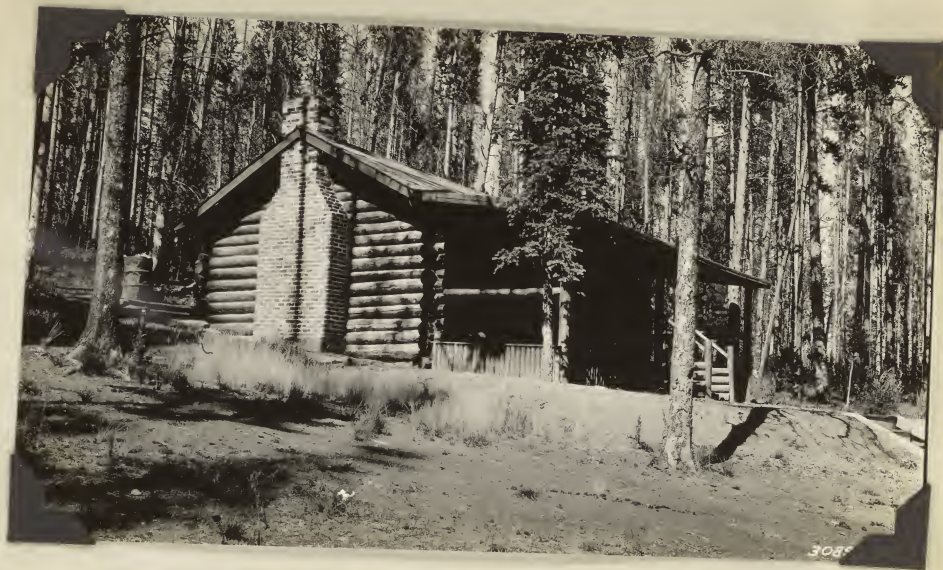
Deerlodge National Forest - Echo Lake Area

Detail photograph showing a typical summer camp in the Special Use Area.

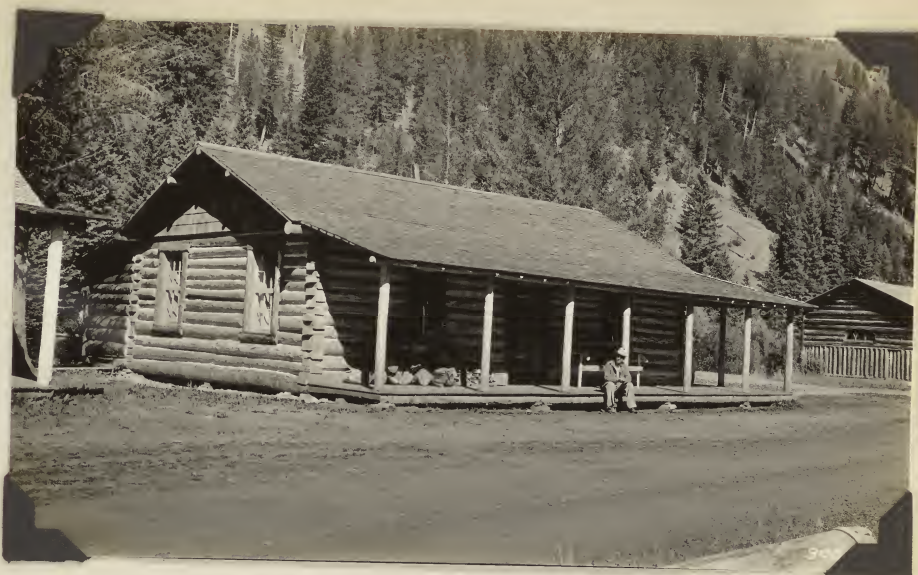
Gallatin National Forest - Karst's Private Camp

General view of a very interesting type of log cabin in use in this camp area.

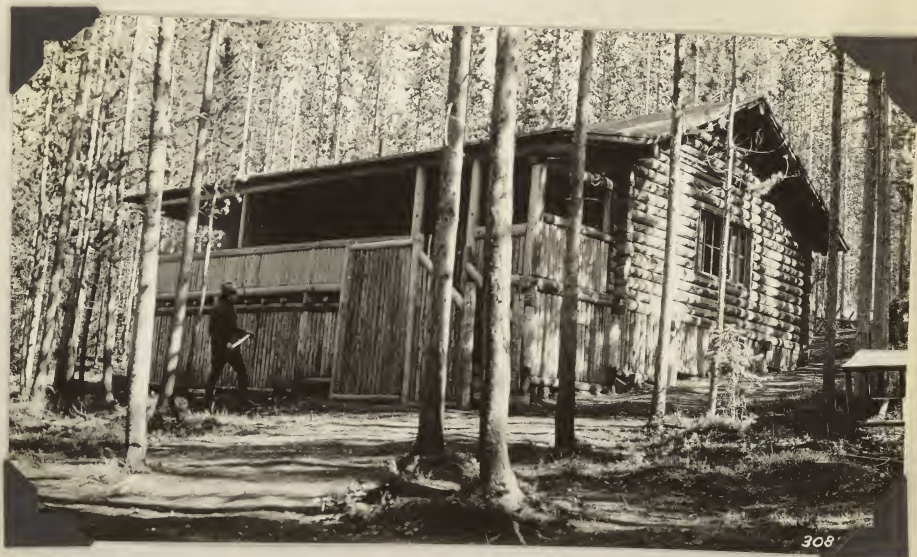
Deerlodge National Forest - Echo Lake Area

General view of a well designed and excellently located summer camp. The problem of providing an appropriate foundation under such structures is one which deserves the most careful study, where the difference between the first floor elevation and the ground surface is as great as in this development. This kind of a foundation is much preferred to the use of stone. It seems to me that the balustrade around the porch is unnecessarily heavy, too high, and too loose in texture.

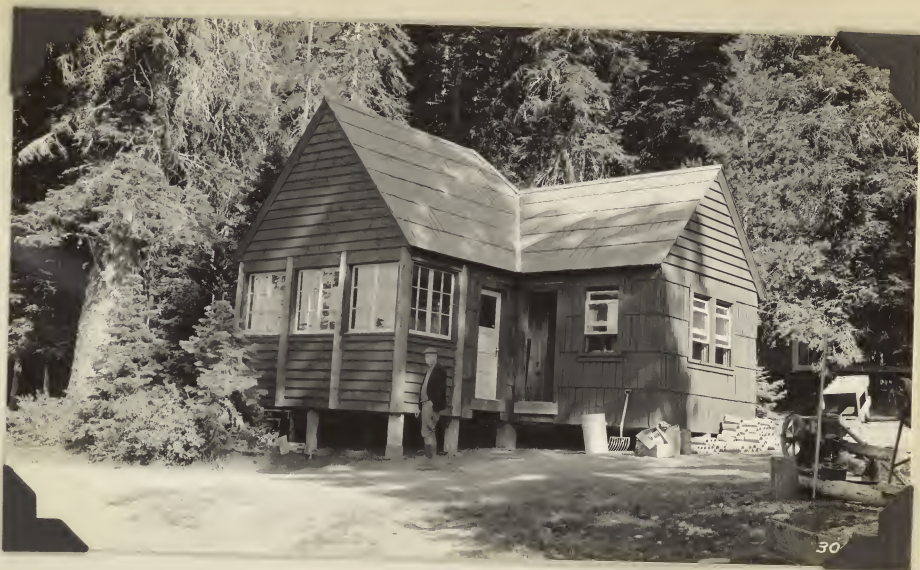
Deschutes National Forest - Diamond Lake

Detail view of an excellently designed summer camp. Unfortunately, the first floor elevation of this building could have been lower, approximately 18 inches. It is proposed to build a stone masonry foundation under this structure and to provide adequate foundation planting. Note the "shakes" used on the roof and on a portion of the sides of the building.

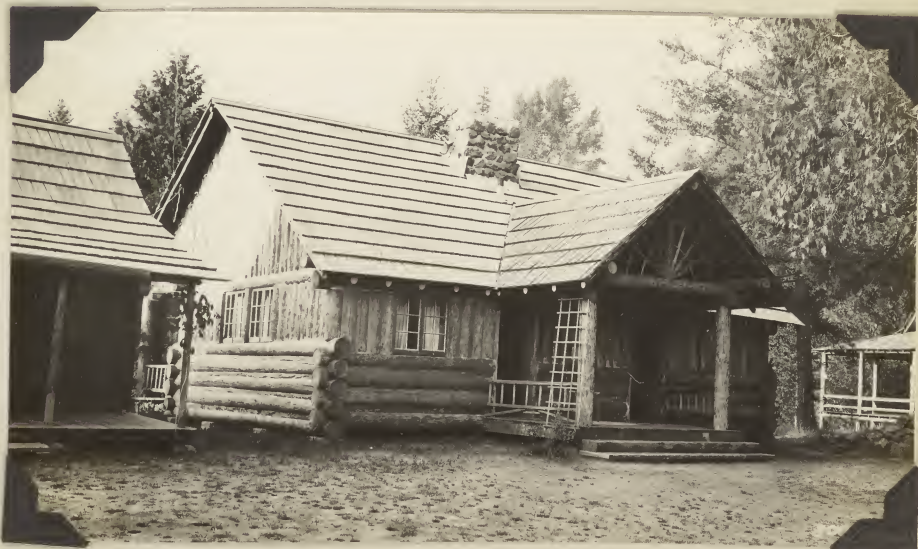
Willamette National Forest - Private Camp Area, McKenzie Bridge

Detail view of a very interesting log cabin which would be most appropriate for use in any forest area. Note the shingled roofs on these buildings.

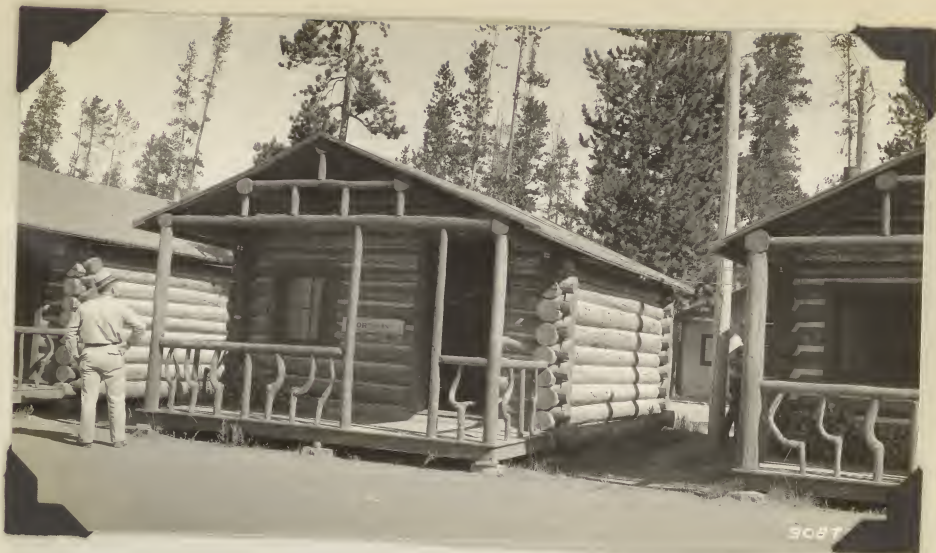
Yellowstone National Park - near West Yellowstone Entrance

Detail view showing a typical mountain camp or log cabin of rather attractive design. The roof is covered with tar paper and the design would be much more attractive if the roof were covered with shingles.

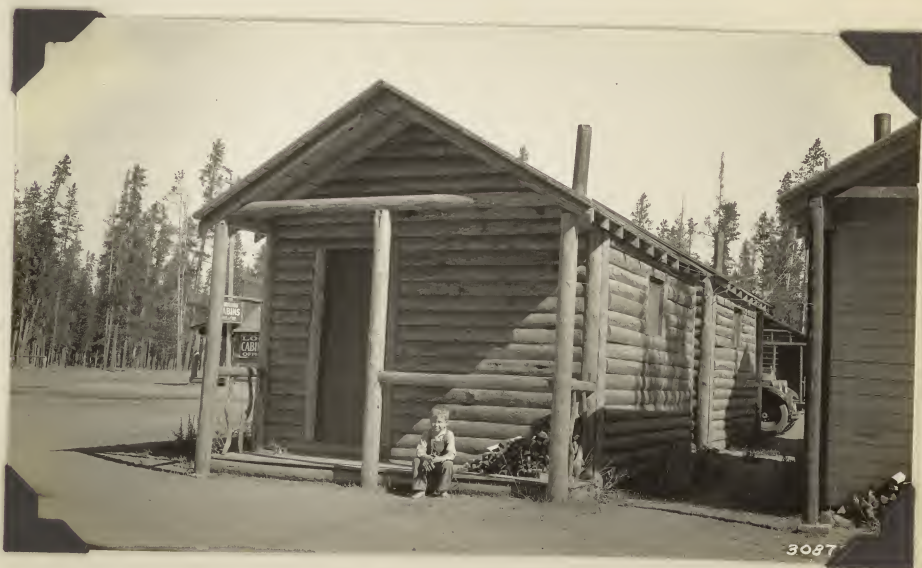
Yellowstone National Park - near Yellowstone Entrance

Detail photograph of a very attractive small cabin of excellent design. The cabins, however, are too close to each other and not enough consideration has been given to the problem of providing appropriate and adequate planting of native shrubs and trees adjacent to the buildings and especially at important points around the base of the structures.

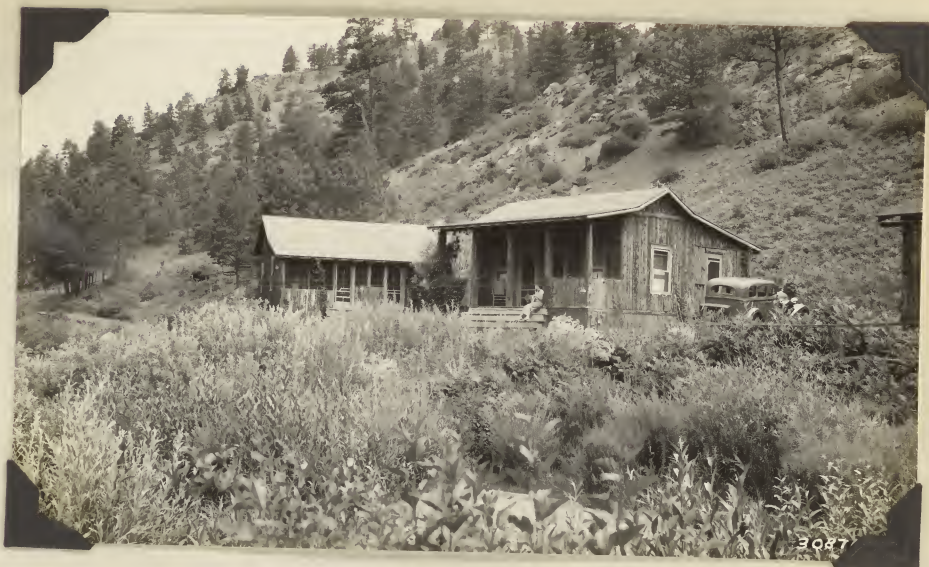
Pike National Forest - Wigwam Club

Two rather interesting types of private camps or mountain cabins.

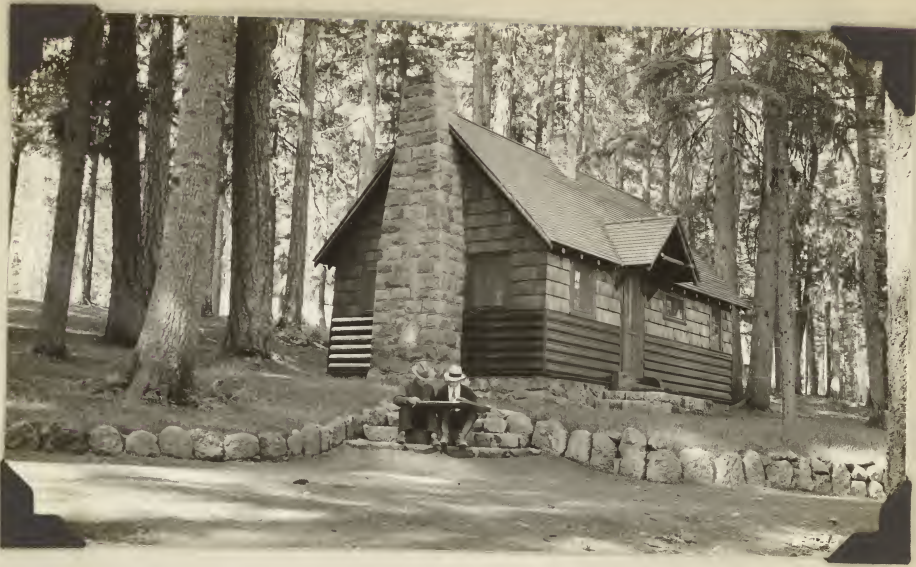
Mount Hood National Forest - Clackamas Lake Ranger Station

General view of a cottage constructed as one of the group of ranger station buildings. A more appropriate design would be accomplished if the shingles had been carried to the "floor" line. Buildings in such locations should also have adequate planting of native materials.

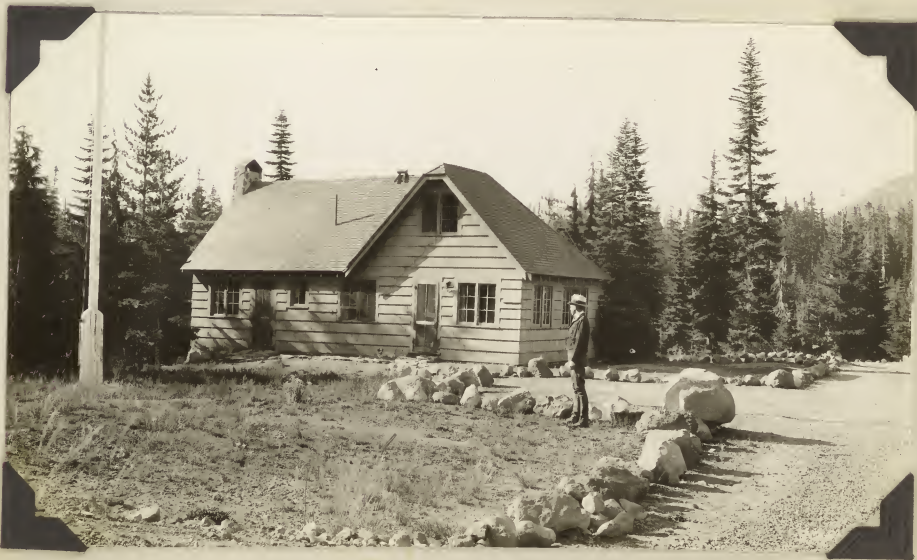
Mount Hood National Forest - Summit Forest Guard Station

This Guard Station is occupied during the summer months, and is of very attractive design. It is badly in need of additional planting to provide a more natural woodland setting and to eliminate the overpowering effect of the abundance of stone used to define the traffic areas.

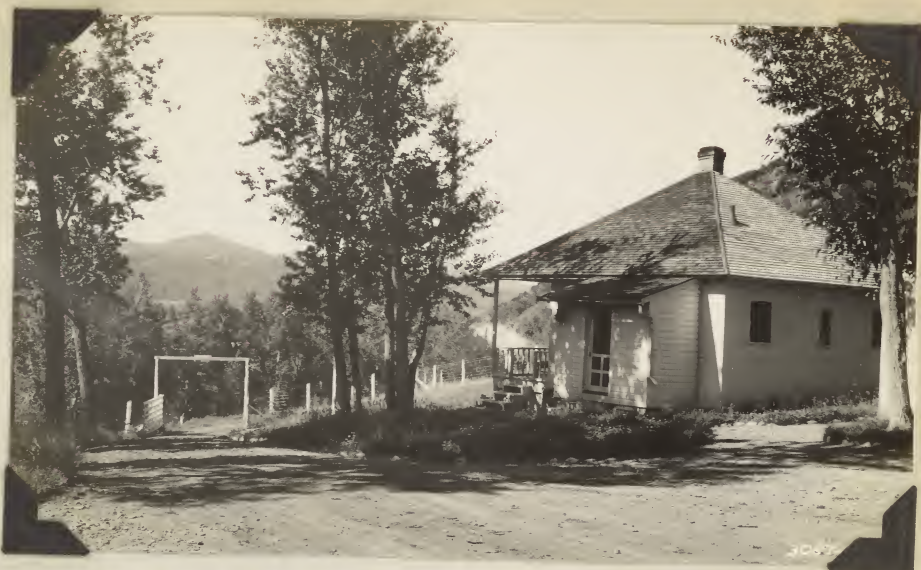
White River National Forest - Lost Creek Ranger Station

View looking down the entrance drive, across the valley toward Buford Peak. Plantings of native materials should be made around many of these ranger stations to eliminate the barren and artificial effect. This is typical of architecture adopted for Ranger Stations in Region 2.

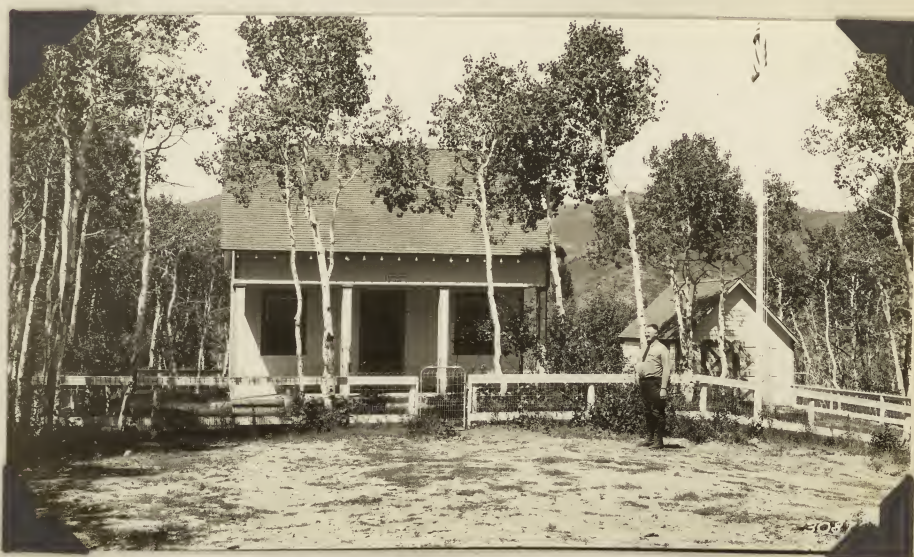
Wasatch National Forest - Timpooneke Ranger Station

A view of a typical design for ranger stations in Region 4. This small building is "over-powered" by the necessary expanse of barren area in the entrance feature. Around all ranger stations in such locations, an effort should be made to provide an adequate space between the fence across the front of the building and the front line of the porch.

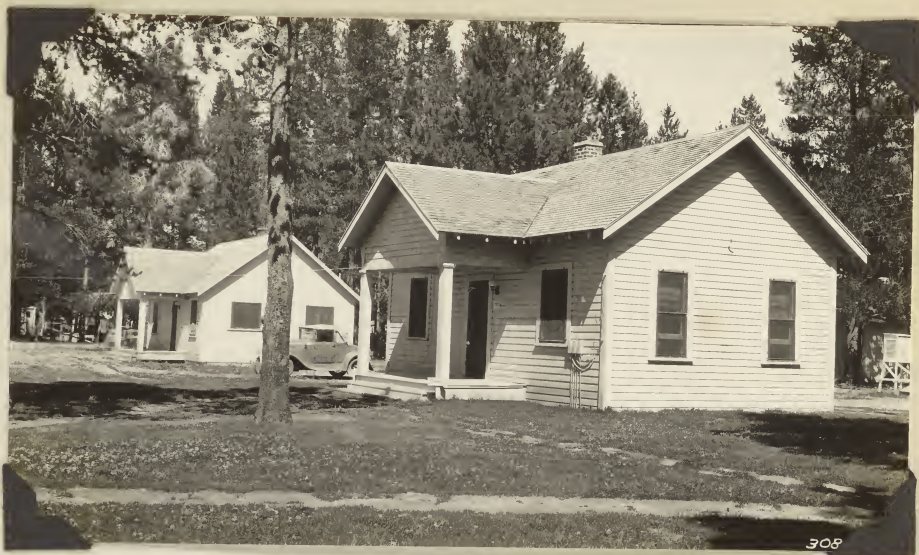
Deschutes National Forest - Crescent Lake Ranger Station

General view of the Ranger Station showing the need for appropriate plantings of native material to frame properly the architectural composition. Planting in this location is difficult because of the limited rainfall, (approximately 10 inches annually).

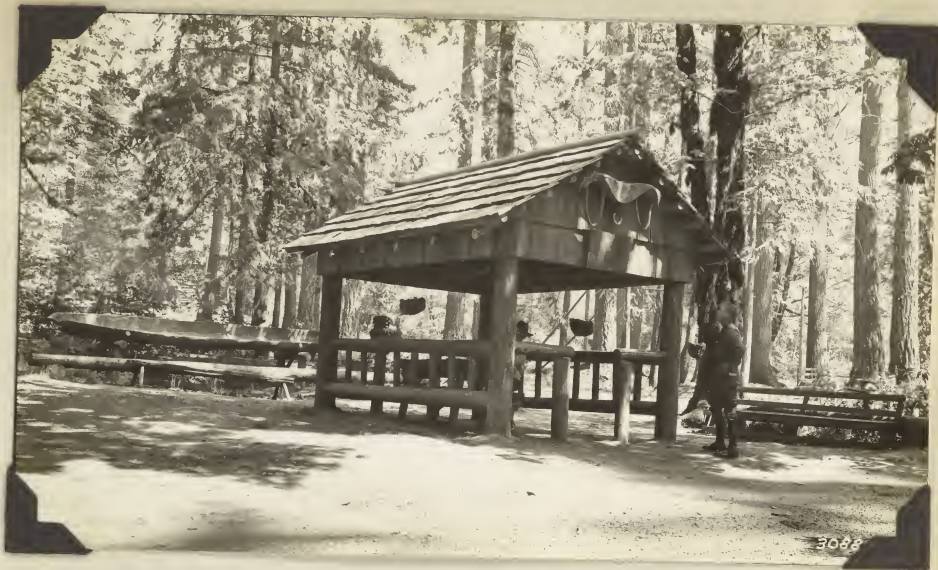
Lewis & Clark State Park - Forest Camp, Washington

Detail of registering building. This building is a very appropriate type for camp grounds and picnic areas. It is not in a natural setting because of the absence of any planting immediately adjacent to the structure.

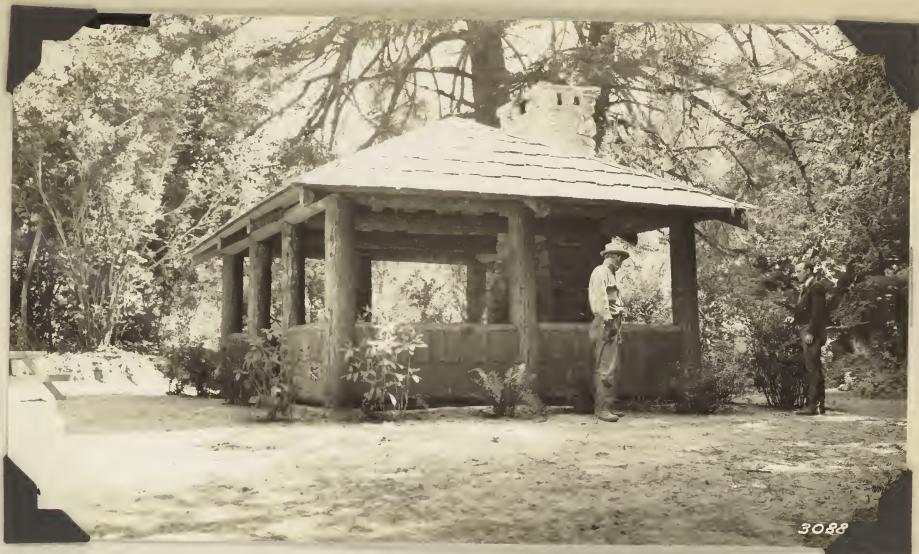
Siuslaw National Forest - Siltcoos Outlet Forest Camp

Detail of an appropriately designed community building, containing provision for two camp stoves and an open fireplace.

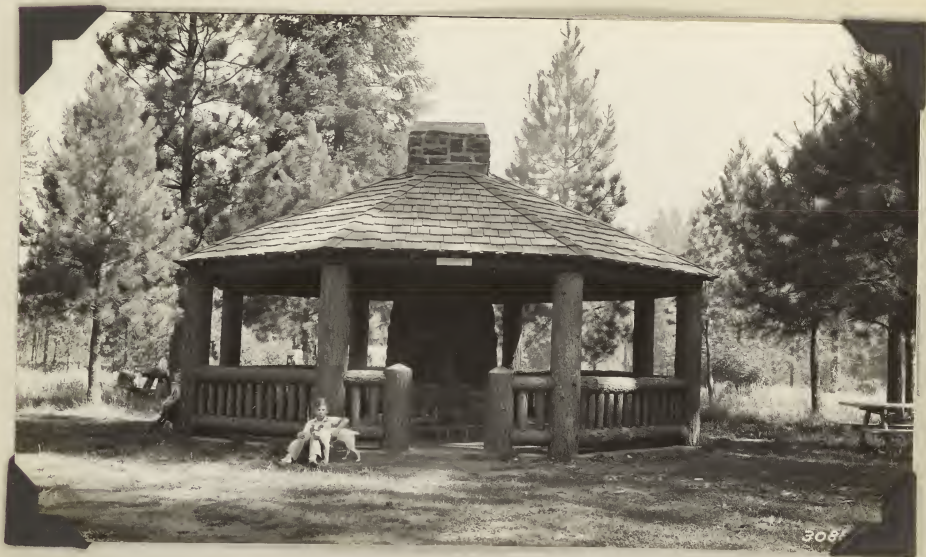
Deschutes National Forest - Metolius River Camp

Detail view of "community kitchen" with cooking ovens and fireplaces. A very excellently designed structure.

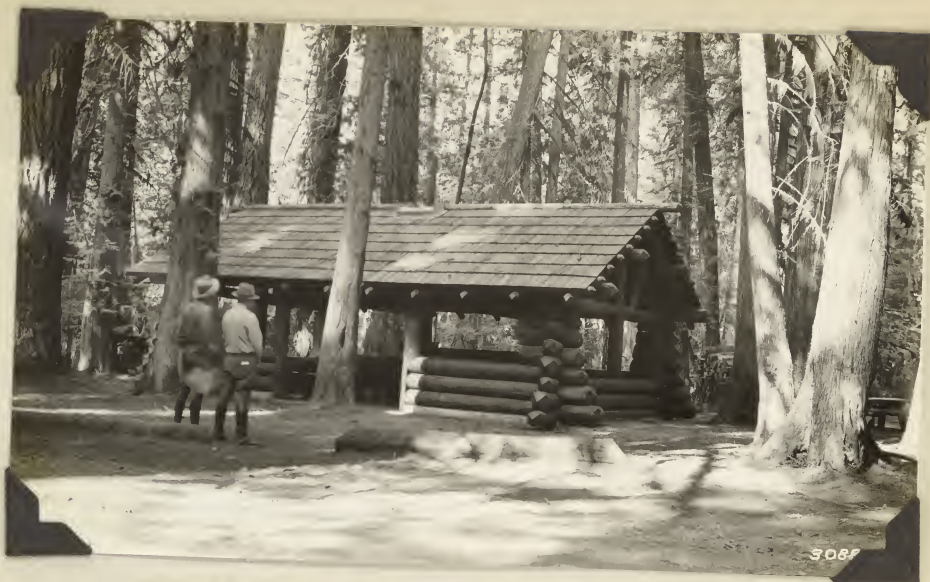
Columbia National Forest - Clear Fork Forest Camp

General view of the community kitchen building located among the large hemlocks. This is an appropriate building for this area. The camp stoves within this building could be better arranged by keeping this unit at the back of the structure rather than in the middle of the floor area.

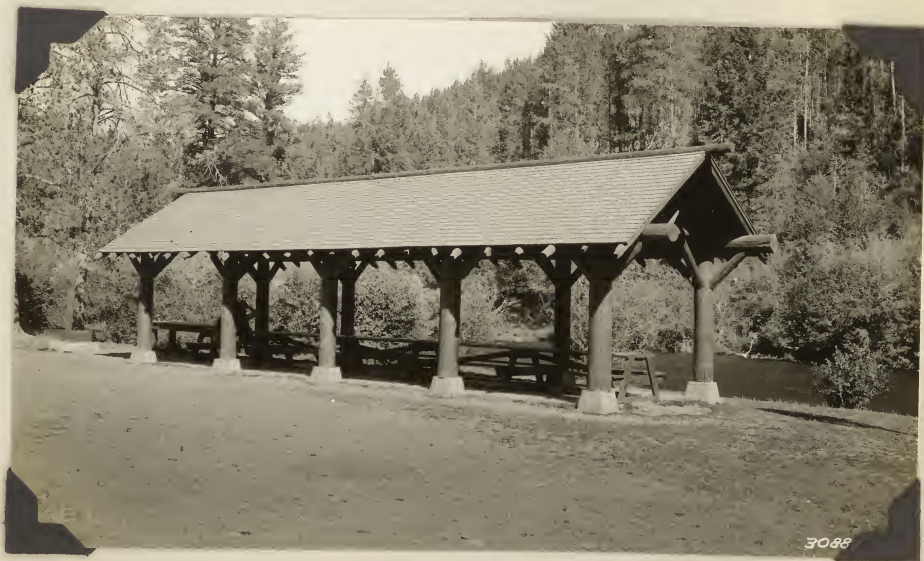
Targhee National Forest - Warm River Forest Camp

A view of the large community shelter building erected for the use of picnickers. This is an excellent type of shelter which might well be considered, in modified form, for use at the "Overlook Point" on the Grand Mesa Plateau, near the rim.

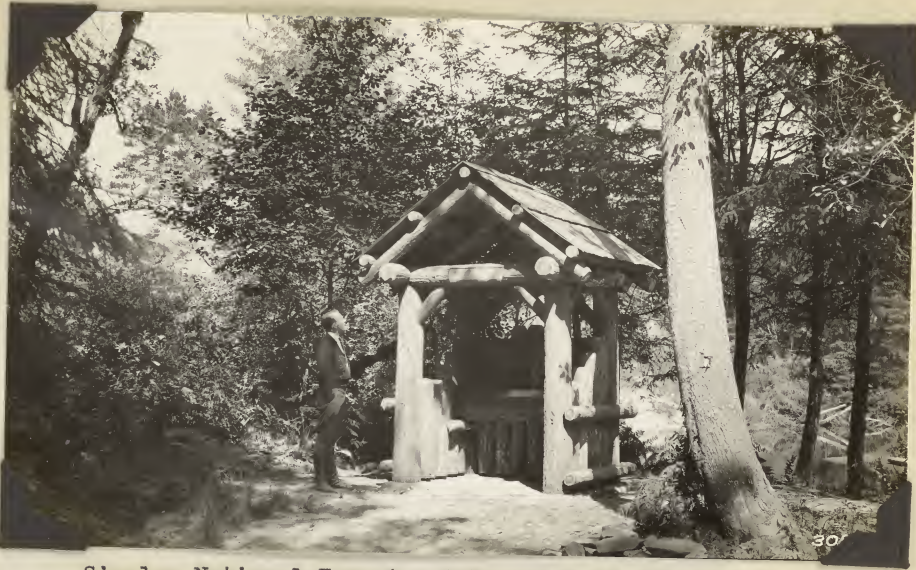
Siuslaw National Forest - Siltcoos Outlet Forest Camp

This type of registering booth is very appropriate for a forest camp area but can be fitted more naturally into the forest surroundings if a few vines and some plantings of native material are used around the base of the structure to properly enframe the feature.
